## EXCHANGE AND REPAIR OF TITANIUM SERVICE PIPES FOR THE XFEL SERIES CAVITIES

M. Schalwat, A. Matheisen, A. Daniel, S. Saegebarth, P. Schilling; H. Hintz, K. Jensch,  
S. Barbanotti, DESY Hamburg, Germany  
A.Schmidt, XFEL.EU GmbH, Hamburg, Germany

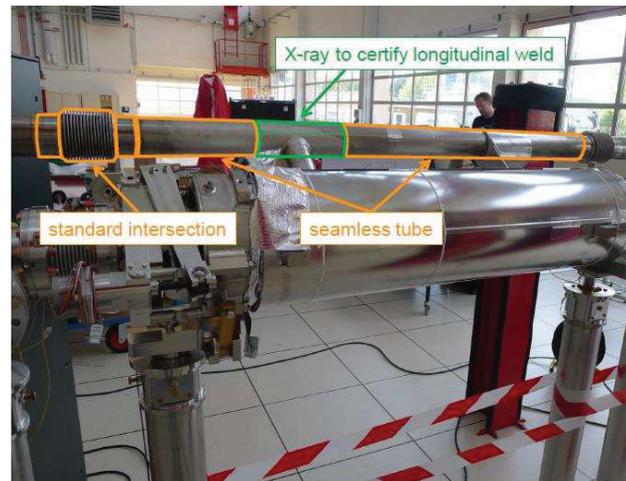
Figure 1: Sketch of the repair work, green part (Chimney) not exchanged during HSP repair.

About seventy HSP showed pores in the so called chimney area (the connection between the main tank body and the HSP, see Figure 1) where no exchange was possible. Therefore an additional repair with manual TIG welding was performed at the company E.Zanon Spa following a TÜV qualified repair procedure.

The exchange of longitudinal welded HSP outside of the so called chimney area (Fig. 1) is done in five steps. The procedure is identical for individual helium tanks and tanks already welded to the 1.3GHz EU-XFEL resonators.

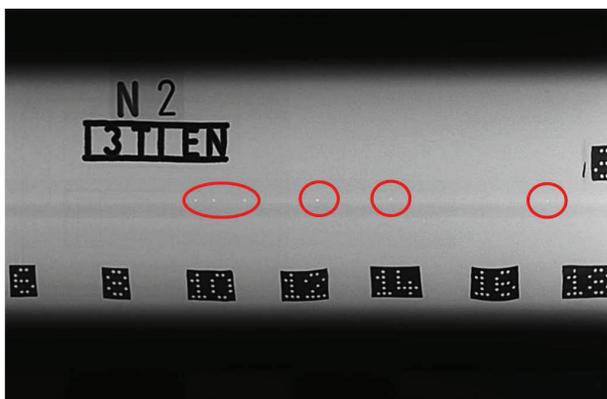
During the first X-ray investigations (Fig. 2) it was found that many of the HSP longitudinal welds contained pores bigger than acceptable according to the DESY specifications. DESY took the decision to X-ray all the longitudinal welds of the HSP and remove all the pores bigger than 0.4 mm. These pores might be the origin of the problem for the pores, which were seen in the round welds at CEA. It was found that this required the exchange of all the pipe extremities (Fig. 1) with seamless pipes for about 620 already produced tanks. The exchange of the complete HSP with a seamless pipe was possible for about 180 tanks still under production.

Figure 2: Example of X-ray picture from a service pipe with pores embedded in the longitudinal weld.

1. X-ray of longitudinal welds to determine pore free areas for the exact position of the cutting (Fig. 2 X-ray picture) to avoid the creation of pores while re-welding the remaining longitudinal weld at the chimney area.
2. Cutting the HSP at the defined position and machining for planarity. Cutting the seamless pipe to same length as the removed tube (Fig. 3).
3. Installing the helium tank to the weld cabinet. A dedicated support has been developed to guarantee the final alignment requirements of the pipe ends (Fig. 4).
4. Welding the connection from longitudinally welded- to the seamless pipe with an automatic orbital welding machine (Fig. 5+6).
5. Verification of quality of orbital welds by Non-Destructive Testing (NDT).

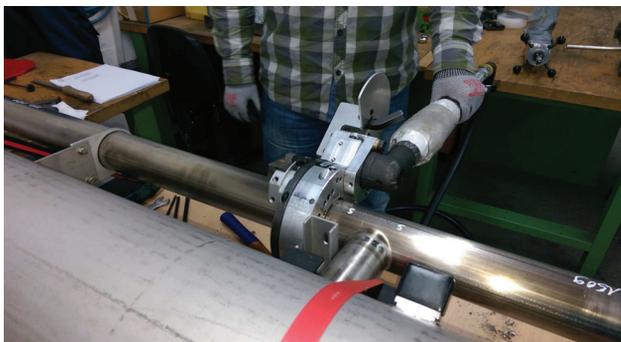
Figure 3: Cutting of helium service pipe at the position defined after X-ray examination.

The pipes are cut with a commercial cutter (TriTool Inc., Mod.602.5SB) (Fig. 3) and the weld area is machined for planarity.

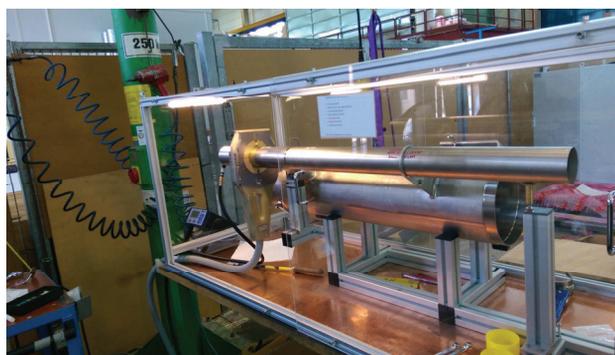
Figure 4: Helium tanks under HSP repair installed to weld cabinet and alignment support.

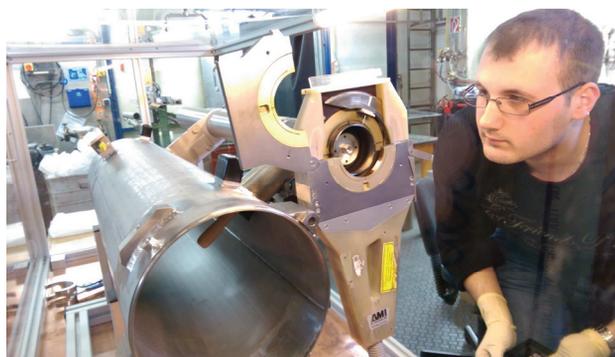
Figure 5: Alignment of welding needle of the orbital TIG welder to the weld plane at the chimney.

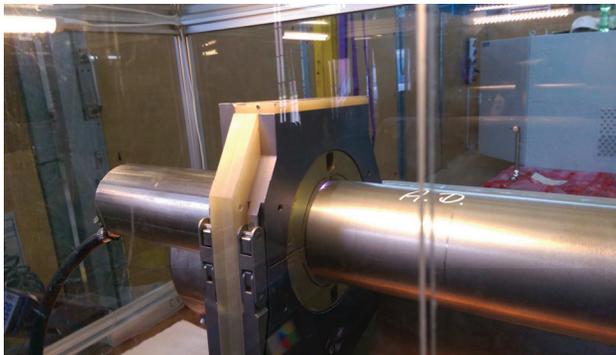
Figure 6: Helium service pipe during orbital welding (weld arc on top of tube).

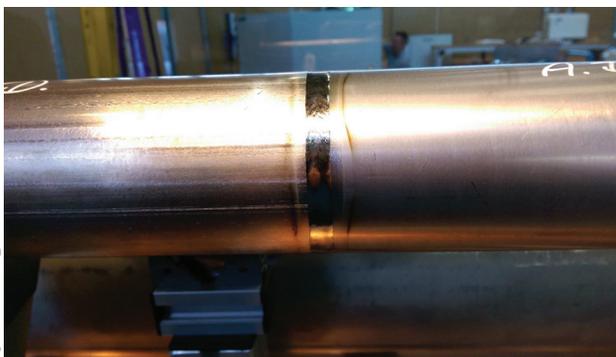
Figure 7: Orbital weld after exchange of HSP.

- 100% Visual test (VT) of the outer and inner weld areas and surface via mirror (Fig. 7).
- 100 % Helium leak test (LT) of the individual welds.
- 100% X-ray test (RT) of the new orbital welds (Fig. 2).

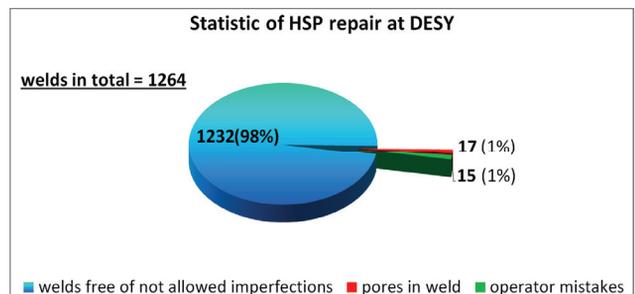
For individual helium tanks the qualification by VT, LT and RT of the individual, welds described above, demonstrates that the repair welds satisfy all the quality and safety requirements according to PED and DESY specifications (Fig. 8).

Figure 8: Statistic of HSP repair at DESY.

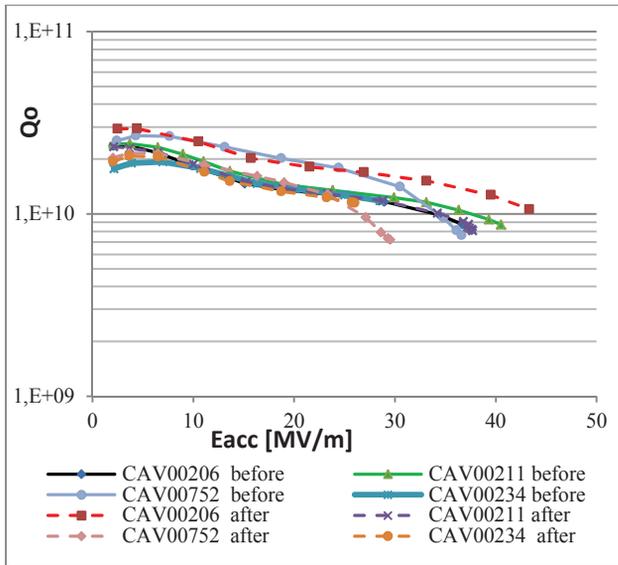
Figure 9: Example on Rf test for statistical prove of resonators before and after HSP and chimney repair.

The majority of tests done until August 2015 reproduced the acceleration gradient from test's done before chimney repair (Fig. 9) within the tolerances of RF test. Only two cavities showed different values.

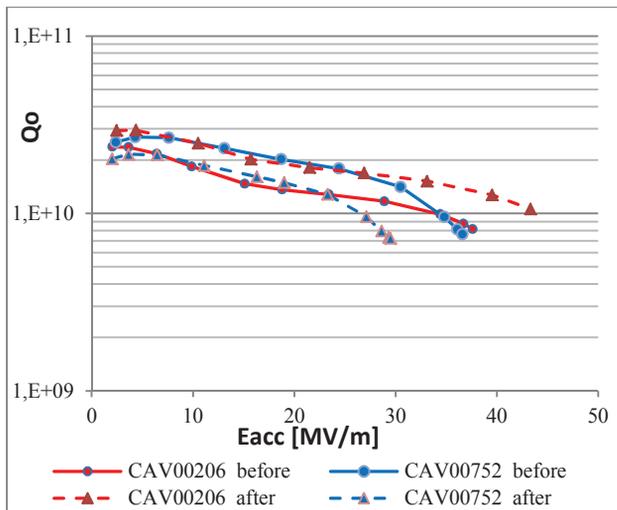
The degradation of cavity CAV-HT00752 can be explained by impact in transport or handling. At CAV\_FE00206 the performance increase by about 7 MV/m without additional treatments (Fig. 11) is unexpected and under investigation. Most likely the change of the Kt factor (coefficient of expansion) between the two test's is responsible for this increase of gradient measured after chimney.

Figure 11: Test result of cavities with performance changes after chimney repair.
