MEASUREMENT OF THE VIBRATION RESPONSE OF THE EXFEL RF COUPLER AND COMPARISON WITH SIMULATED DATA (FINITE ELEMENT ANALYSES)

S. Barbanotti[†], K. Jensch, C. Engling
Deutsches Elektronen-Synchrotron, 22607 Hamburg, Germany

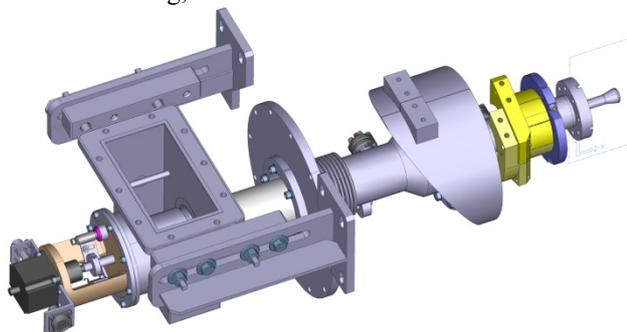
Figure 1: a EXFEL coupler

The EXFEL project has adopted with minor modifications the TTF-3 coupler design (see Figure 1) to power the 1.3 GHz TESLA-style cavities in its linac [1]. These couplers were developed within the TESLA collaboration in the last 30 years to be used for pulsed operation with several hundred kilowatts of input power at a $\sim 1\%$ duty factor.

The 800 EXFEL couplers (Figure 1), being the cryomodules assembled at the CEA (Saclay) facility, were transported completely mounted in the cryomodule from the French site to the final test and installation site at DESY Hamburg, a distance of about 900 km.

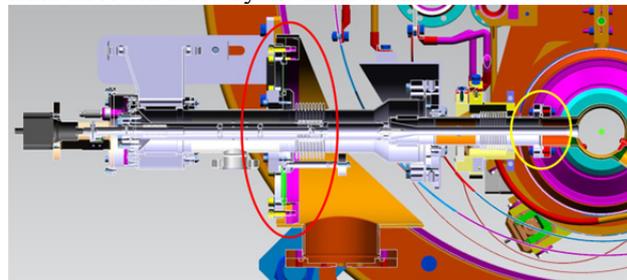
The analyses were performed on the “movable” part of the coupler. Figure 2 shows a section of a coupler with on one side the connection to the accelerating cavity (circled in yellow) and on the other the connection to the outer vessel of the cryomodule (circled in red). Thanks to the 2 bellows in-between the 2 connections, the middle part is free to move in the vertical and lateral direction, being the axial direction fixed by the inner antenna.

Figure 2: Section of an EXFEL coupler assembled in the cryomodule; in red and yellow the connections to the module (fixed points).

For the simulations, we considered only the part free to move (between the yellow and red circles) since the two “extremes” are fixed to the cryomodule once the coupler

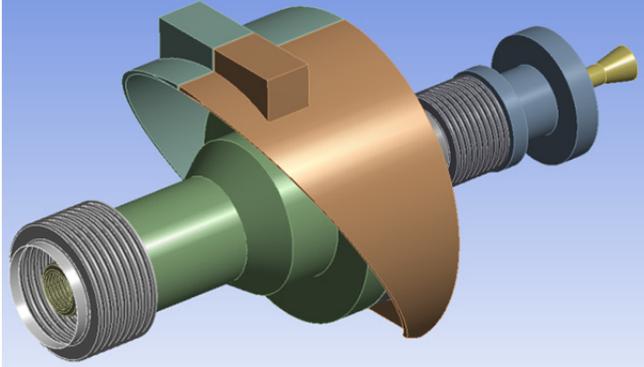
is fully assembled. The 3D CAD model was simplified removing all unnecessary components, openings, and design details not relevant for the analyses (see Figure 3).

Figure 3: the Finite Element Model

The model for the modal analysis was fixed at the bellows extremities in all directions (fixed support) while the inner support of the antenna at the warm side was fixed only in the axial direction (to simulate the bayonet connection).

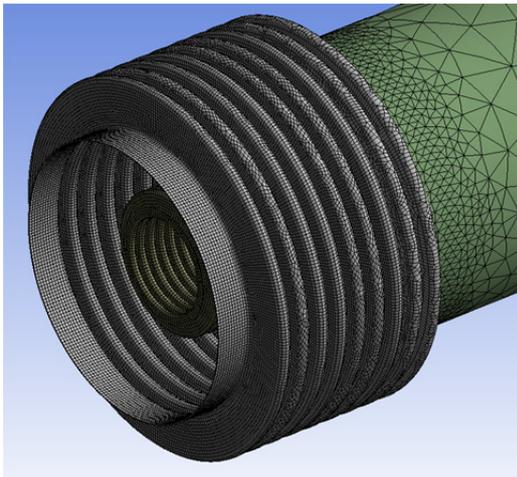
The simulations were performed with Ansys Workbench. Figure 4 shows as an example the mesh of one of the bellows. The overall mesh has 1.060.000 elements and 170.000 nodes.

Figure 4: a detail of the mesh

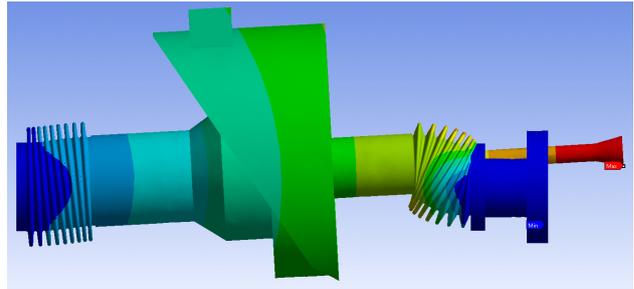
The first eigenmodes of the modal analysis are summarized in Table 1. The first lateral and vertical mode are at ~18 Hz. This mode, relevant for our analysis, is shown in Figure 5.

Figure 5: the profile of the 1st Eigenmode

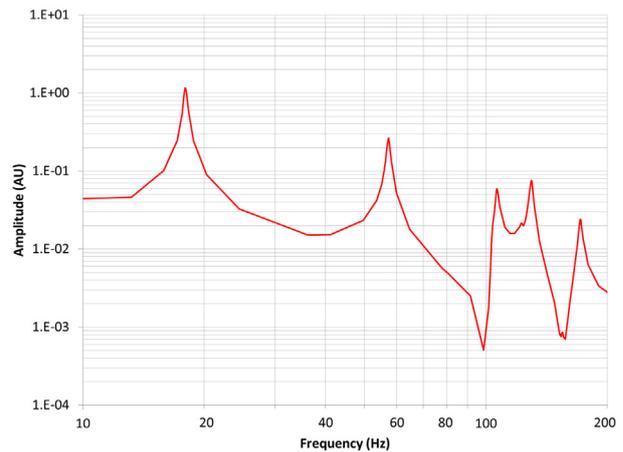
Figure 6 shows the frequency response of the 80 K interface in the range 0 – 200 Hz. The three frequencies

highlighted in the modal analysis are evident, with the higher amplitude for the first mode (~20 Hz).

Figure 6: the harmonic response at the 80 K interface

The harmonic response analysis was performed as “mode superposition” analysis, i.e. using the results of the modal analysis as input. A lateral force of 10 N at the 80 K interface was the only load applied.

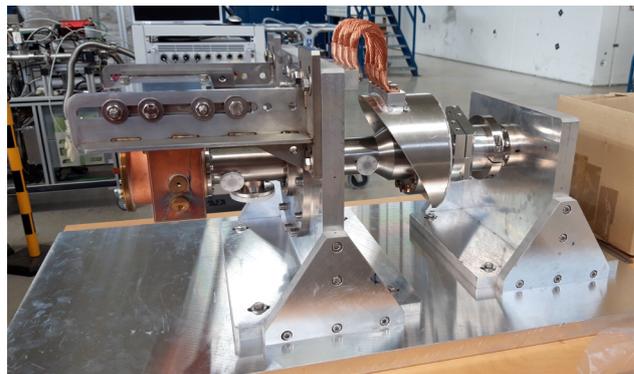
In June 2019 we performed a vibration study on the EXFEL coupler. We assembled the coupler on a test support (Figure 7) and instrumented it with various sensors to measure the acceleration during a shaking test performed at the BFSV Verpackungsinstitut Hamburg GmbH.

Figure 7: the coupler on the test support

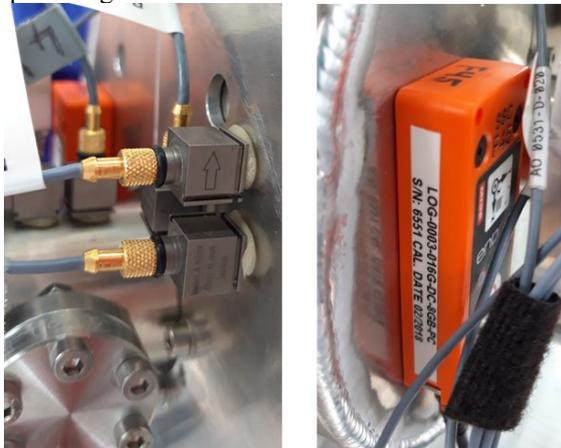
The slam stick and the piezoelectric sensors were positioned on the fixed coupler support and on the movable 80 K interface (Figure 8), while, thanks to their reduced dimensions, 2 additional B&K sensors were positioned very close to the cold bellows. The piezoelectric sensors were positioned on the fixed support and on the small coupler flange next to the cold bellows.

Figure 8: the coupler with the sensors

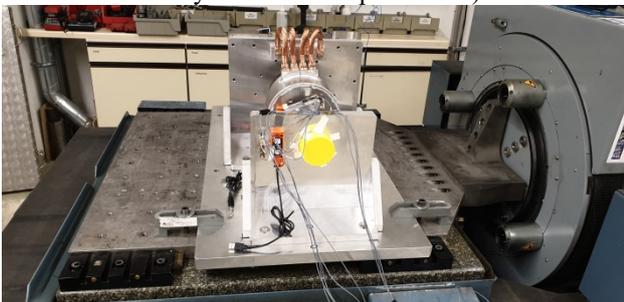
The shaking test was performed with a Vibration tester Unholtz-Dickie Corporation – SA60-T1000/AR. The vibration test rig was set up with a horizontal test axis. The coupler was position like in Figure 9, with the antenna axis perpendicular to the shaking axis (to simulate vibration in the longitudinal direction once the coupler is installed on the cryomodule transport frame).

Figure 9: the coupler on the shaking table

”Sweep tests” were performed with the following characteristics: frequency range from 4 to 200 Hz and back from 200 to 4 Hz, acceleration constant at 1 g.

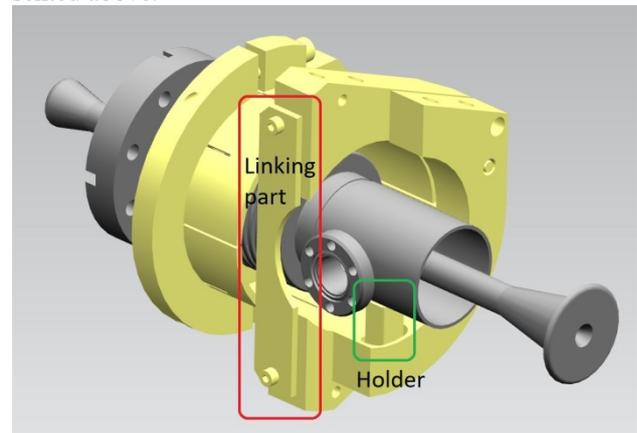
- With the 5K thermal interface fully installed like in an EXFEL cryomodule (test 1)
- Without the linking part on the 5K thermal interface (test 2, Figure 10 highlighted in red)
- Without the whole 5K thermal interface, including the holder (test 3, Figure 10 highlighted in green).

Figure 10: the 5K thermal interface (yellow) with the linking part and the holder

For the third test we decided to completely remove the 5K interface, to simulate the transport condition of a TTF type3 coupler (installed in some EXFEL prototype and pre-series cryomodules) and evaluate the effect of the holder (the small part at the bottom of the 5K interface that avoid free vertical movement of the middle part, see Figure 10).

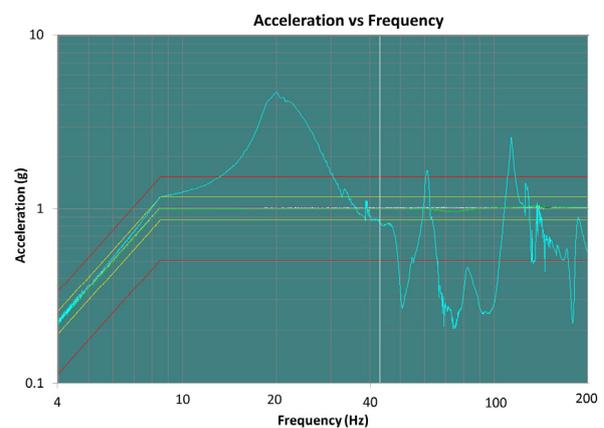
Figure 11 shows the acceleration measured at the coupler port during the first test. Three peaks can be easily recognised, one around 19-20 Hz, one at 60 Hz and a third one just above 100 Hz. These peaks are very close to the results of the modal analysis presented above and the trend of the acceleration vs frequency has a very good agreement with the harmonic response results also presented above.

Figure 11: acceleration vs frequency at the coupler port during the first sweep test (test 1)

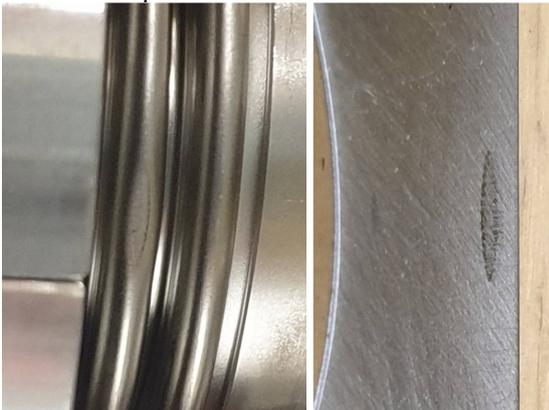
Therefore we decided to remove the linking part and have a look at it. Once removed, it showed a clear damage at the closest point to the bellows and the bellows itself had something like a dent at the corresponding point (see Figure 12).

Figure 12: left, the dent on the bellows – right, the damage on the linking part

At the same time, we could hear something “ringing” when the frequency was close to the first resonance; we suspected the source of the noise to be the cold bellows hitting the linking part, but we were not able to clearly identify it.

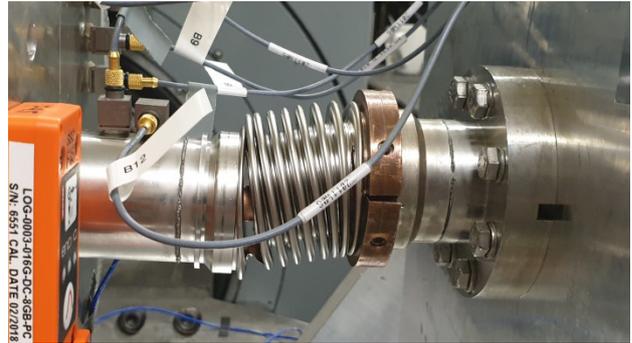
The results on the way “up” the sweep (i.e. increasing the frequency from 2 to 200 Hz) are very similar to the previous ones. But, on the way “back”, when we approached the 20 Hz frequency, the coupler started ringing differently and we noticed that the antenna was moving down. We realised soon after that the bellows was failing and it completely broke before the sweep was back to the starting frequency.

Figure 13 and Figure 14 show the bellows after the failure and the acceleration vs frequency profile during the failure. The peak highlighted in red happened exactly at the breaking moment.

Figure 13: the bellows after the failure at test 3

More important, the vibration test confirmed the cold bellows as the critical point of the assembly in case of transport without any form of support or damping frame.

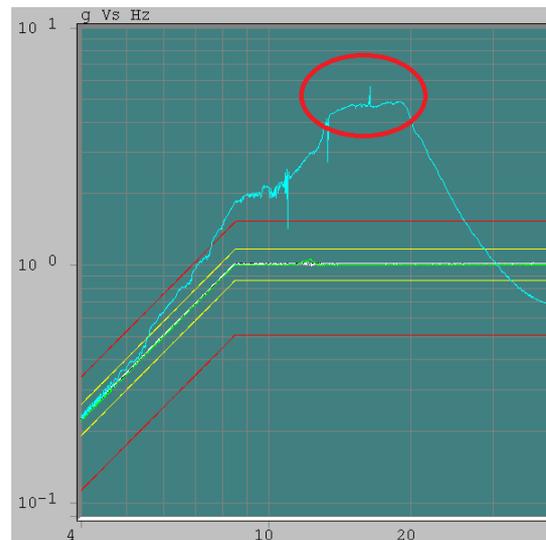
Figure 14: the acceleration vs frequency profile during the bellows failure
